HAMPDEN COUNTY REGISTRY OF DEEDS

DAMS FILE COLLECTION

BOOK D25 – 4 (U-Z)

Reports Section—Dams - Hampden County Massachusetts

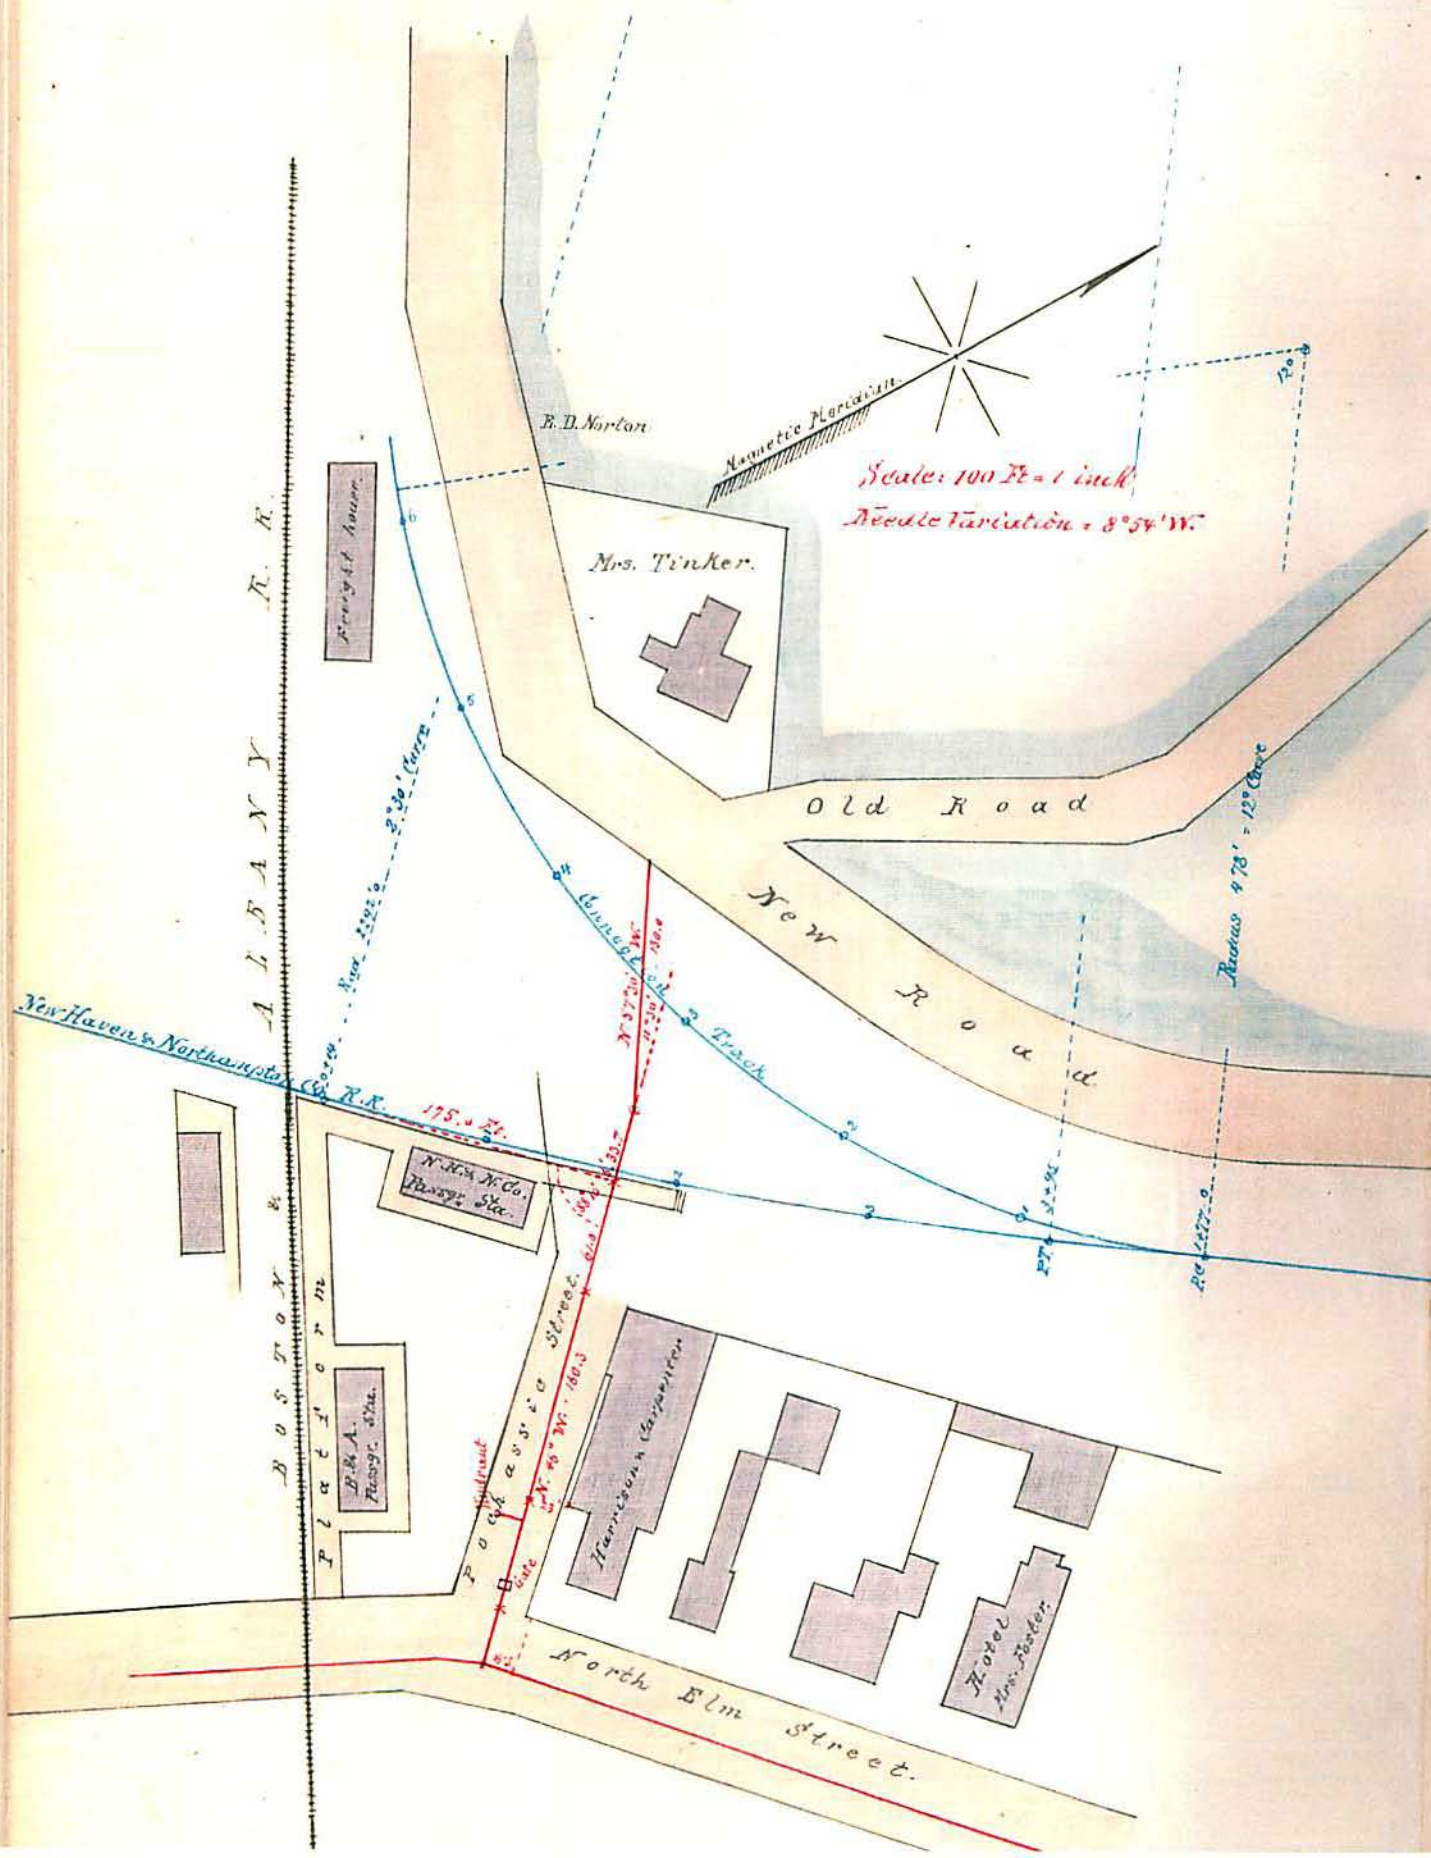
Tracing "S."

Location across New Haven & Northampton Co. R.R.

Commencing at an Elm monument on the westerly line of Hedyoke and Westfield R.R. location and in Easterly line of New Road as built by ~~W. & N. Co.~~ and running $S 57^{\circ} 30' E$ 130 feet to a point $33 \frac{1}{2}$ feet westerly of Centre line of ~~N. & N. Co.~~ Main Track, thence $S 46^{\circ} E$ about 67 feet to the easterly line of N. & N. R.R. Location, The last described line crosses a Tangent produced from P.C. 14 feet North of North Rail of Boston & Albany R.R. at a distance of 175 feet northerly from said North Rail and six feet easterly of Centre line of Main Track of ~~N. & N. Co.~~ The included angle of the tangent lines and line of location running westerly as shown on Tracing is $88^{\circ} 10'$. The above description is for the Centre line of location the width of land taken being one Rod on each side of said Centre line containing 24 rods more or less.

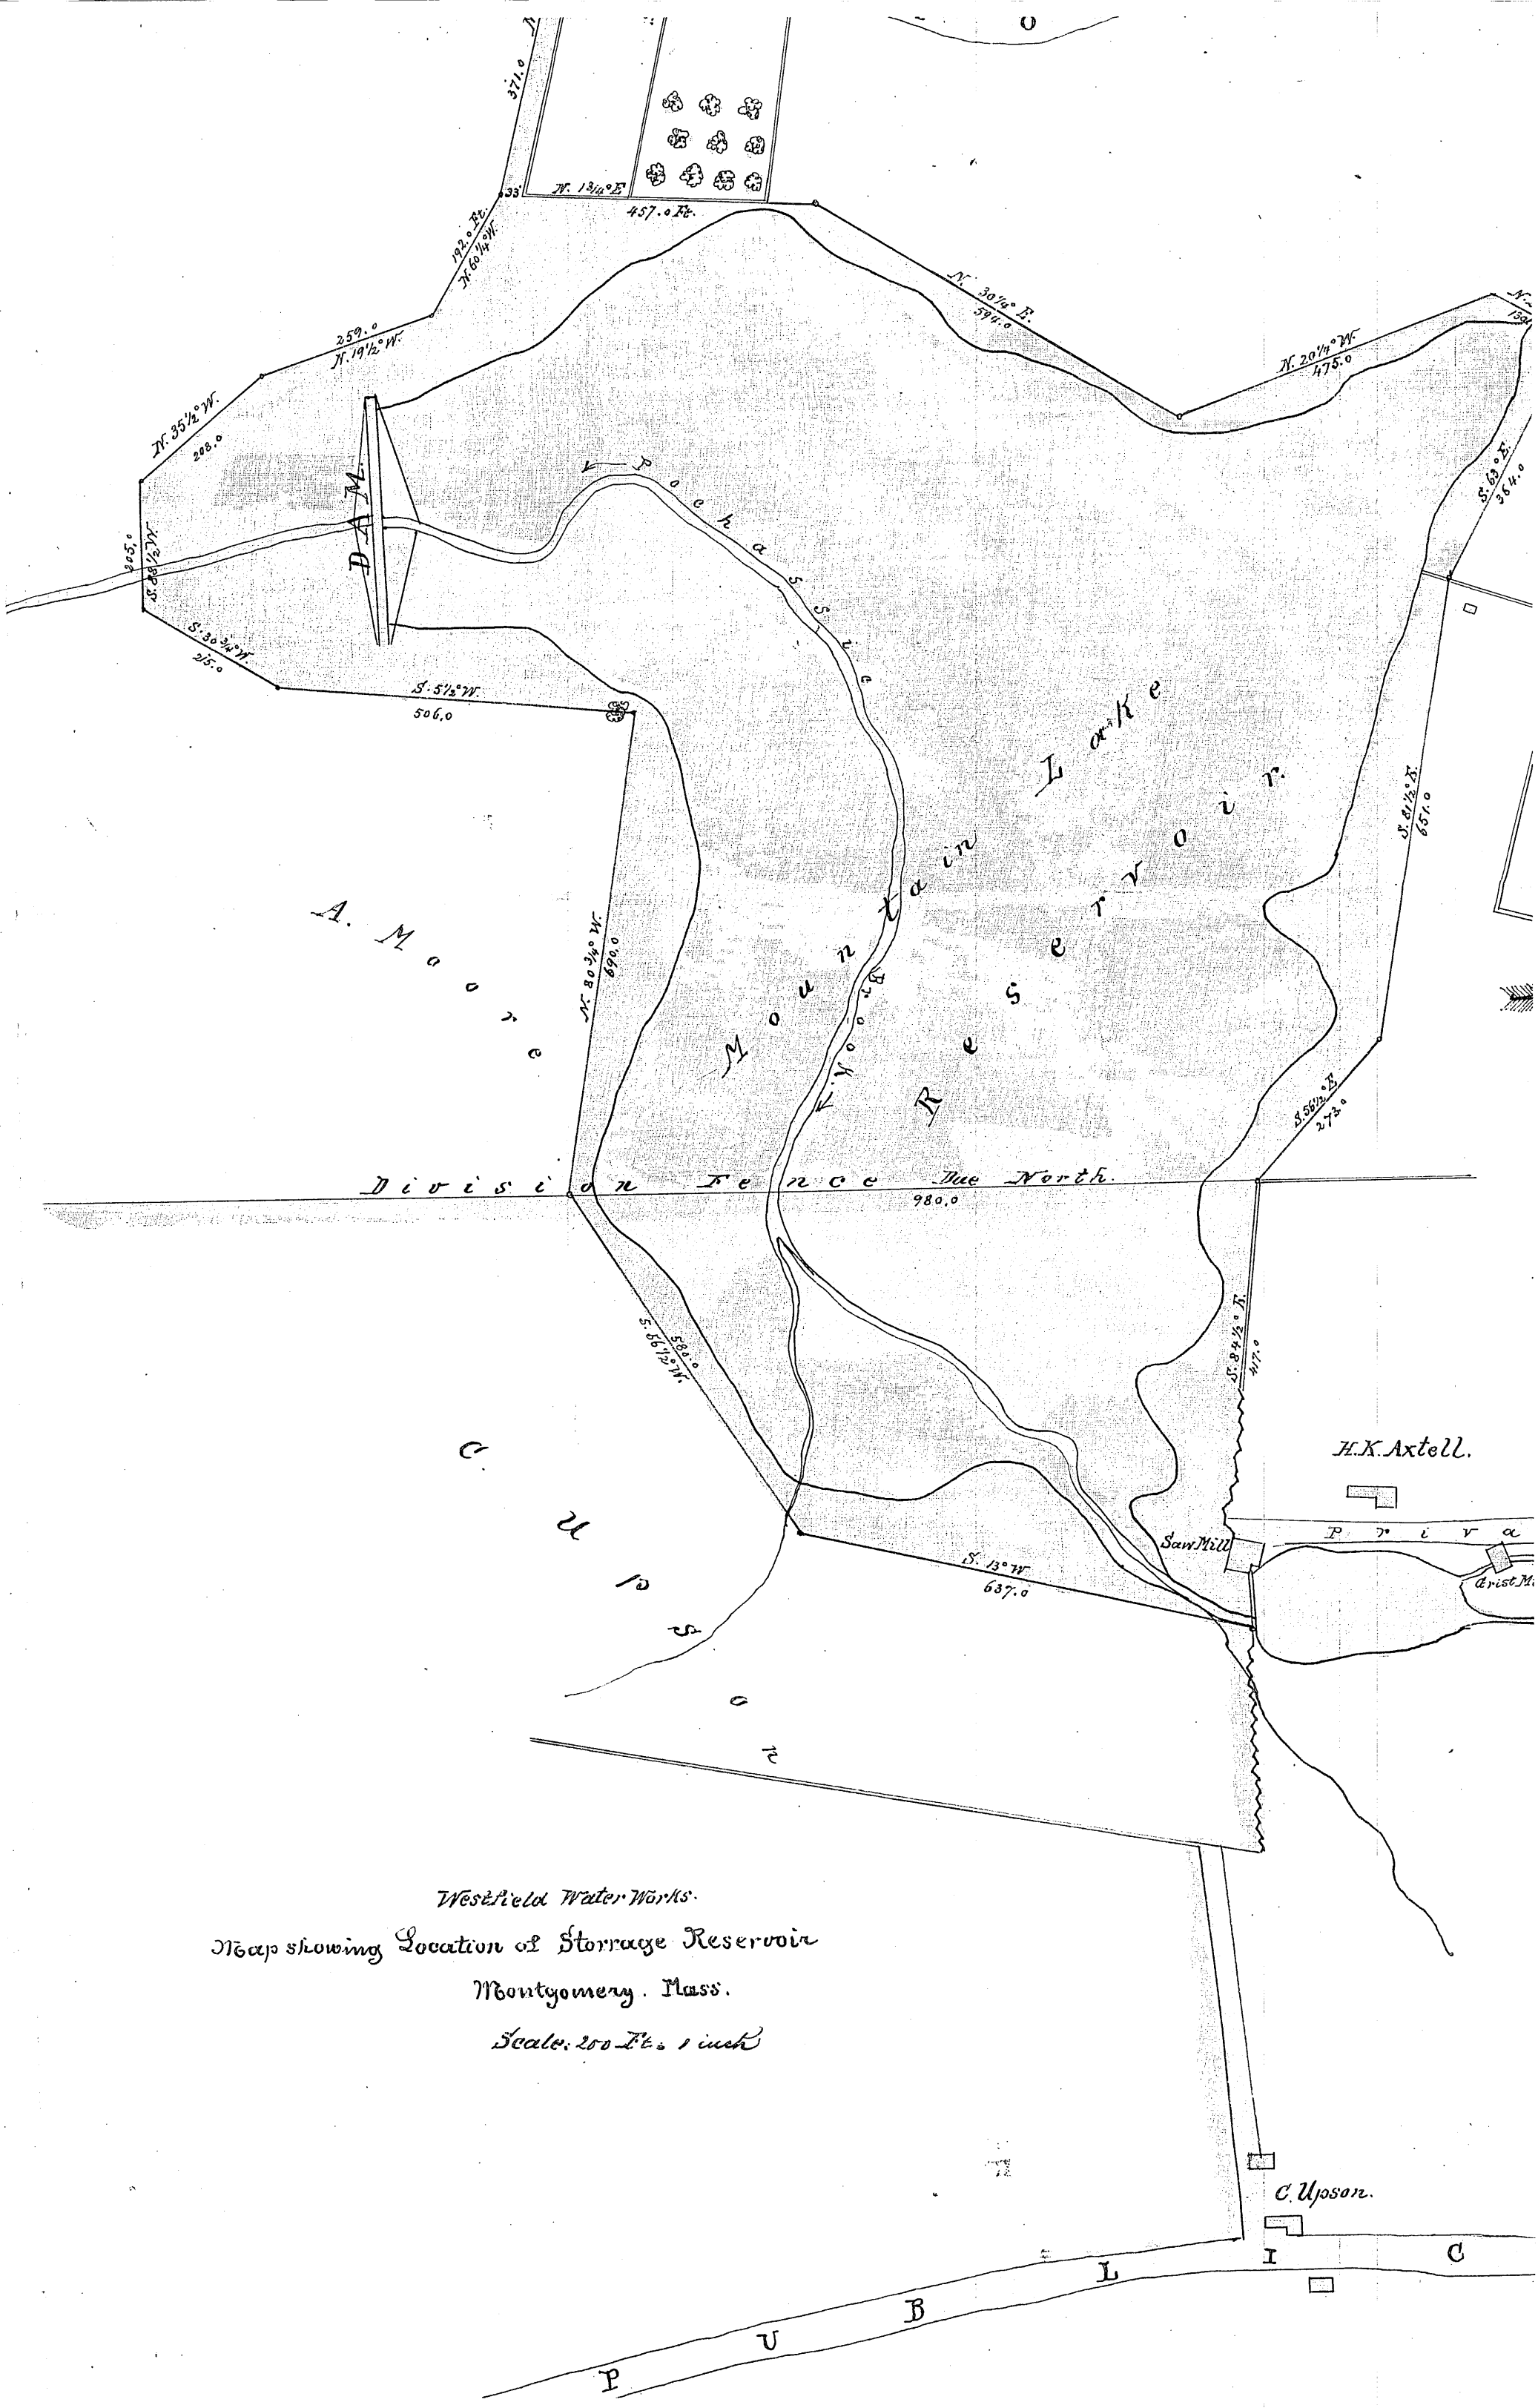
Westfield Water Works.
 Map showing Location of Storage Reservoir
 Montgomery, Mass.
 Scale: 200 Ft. = 1 inch

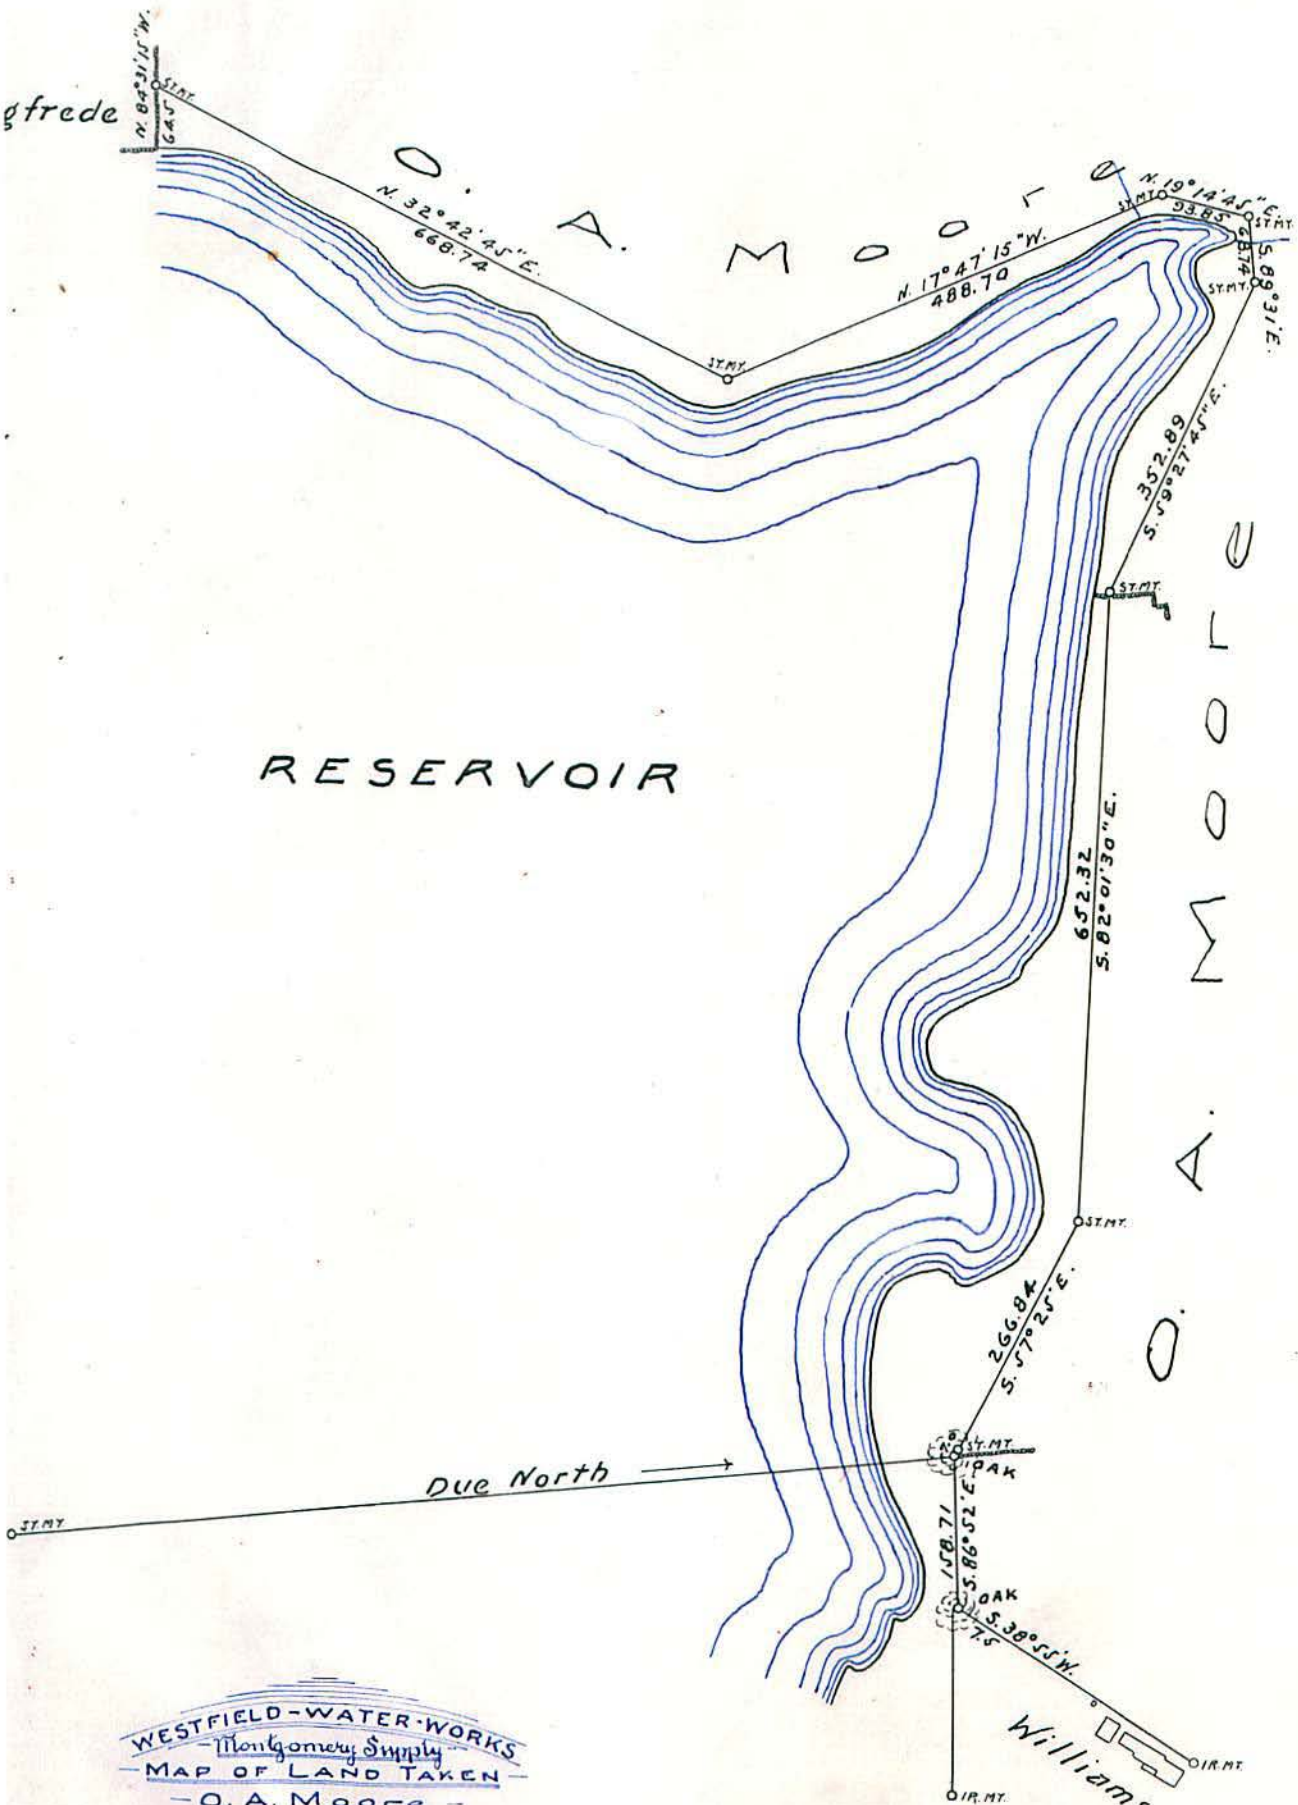
WESTFIELD-WATER-WORKS
 -Montgomery Supply
 -MAP OF LAND TAKEN-
 -O. A. MOORE-
 -SCALE: 200 FT. = 1 INCH.-
 -ORENE PARKS-C.E.-
 -1904.-

Land taken of Oliver A. Moore, November 21, 1904.

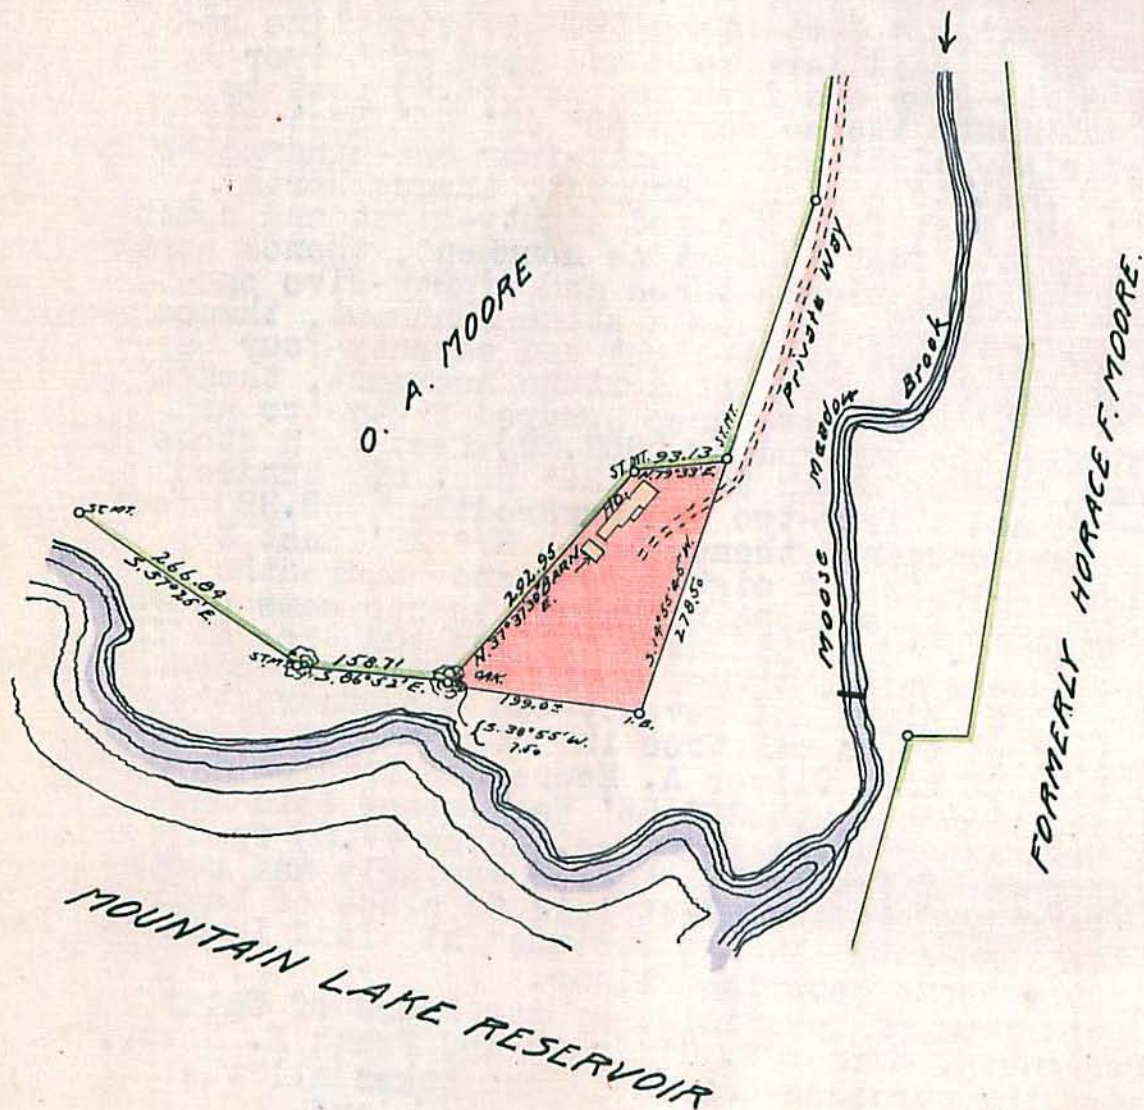
WESTFIELD-WATER-WORKS
 Montgomery Supply
 MAP OF LAND TAKEN
 - F. E. WILLIAMS -
 - SCALE 1200 FT. = 1 INCH. -
 - OREN E. PARKS - C.E. -
 - 1905 -

Land taken formerly of Frances E. Williams, July 1, 1905.
